# Corrosion Protection

*This chapter describes the bonding system that protects components against corrosion.*

Viking 61FY has a bonding system to protect the vessel as much as possible from severe electrolytic corrosion of propellers, shafts, rudders, fuel tanks, etc. caused by electrical currents and warm seawater. Essential to the cathodic protection system is an 8 gauge green and yellow common bonding wire connecting protected components to two sacrificial zinc anodes, port and starboard under the hull.

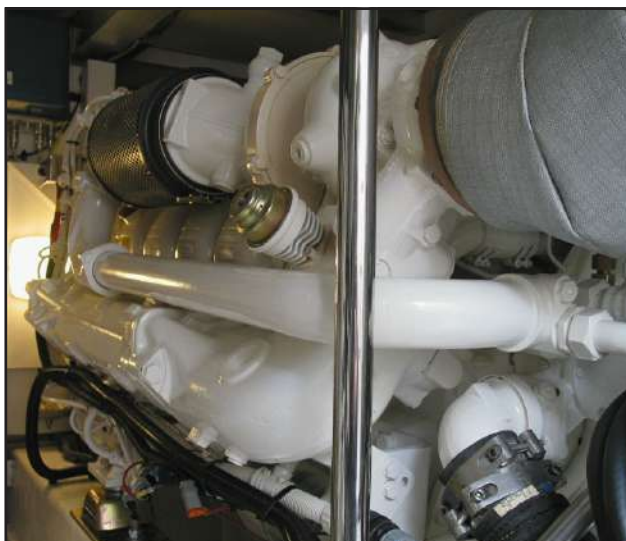
Change internal zinc anodes on schedule

The MAN diesel engines and the Onan generator each have internal zincs which **MUST** be replaced as scheduled – refer to manufacturers' manuals for details. The ZF marine gear also has zinc anodes on the oil coolers, near the seawater inlet and outlet. Check annually or at 500 hours, or if seawater leakage occurs.

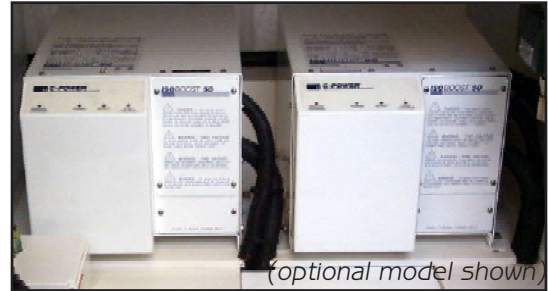
## Isolation transformers

*Isolation transformers effectively give the vessel a 'closed circuit' electrical system that is safe, and will not leak current and cause corrosion.*

In the lazarette the two 15 kVA isolation transformers have a rated input of 100 amps @ 240 volts. Shore power coming aboard is isolated through the transformer windings from any direct contact with outside grounds. ONLY red, black and green are brought into the transformer. In effect, 240 volts AC **ONLY** goes into the primary winding of each transformer. 120 volt power is produced by the transformer. This isolation protects against stray currents and electrolytic corrosion that destroys underwater fittings.

In effect, the vessel has its own CLOSED CIRCUIT electrical system which also protects crew and passengers from potentially lethal electricity flowing through them to a shore ground.

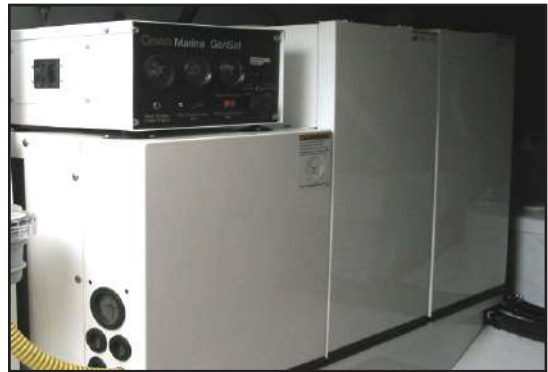
## Onan generator

*Internal zinc anodes must be changed on schedule.*

The engines and generator have their own internal zinc anodes for protection of their metal parts, these **MUST** be maintained according to manufacturers' recommendations.
