225021

# Engine

# 2002 BF200/225

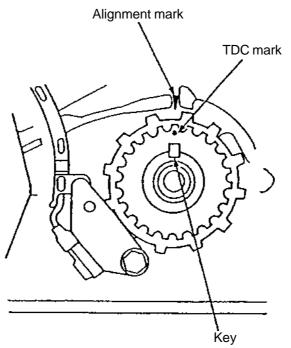
- (1) Remove all the spark plugs.
- (2) Align the TDC mark on the timing belt drive pulley with the alignment mark on the crankcase upper cover.

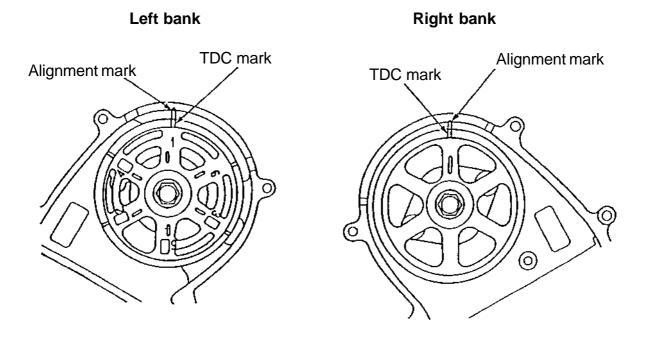
(3) Align the TDC mark on the camshaft pulley at each bank with the alignment mark on the back cover.

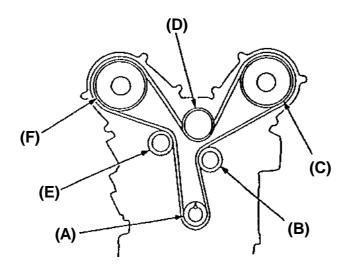
- (4) Loosen the tension pulley fastening bolt by baking it off approximately 1 complete turn from the contact point of its bearing surface.
- (5) Install the timing belt on the pulleys in the following order.
- (A) Timing belt drive pulley (crankshaft)  $\rightarrow$  (B) Idler pulley B (flangeless)  $\rightarrow$  (C) Left-bank cam shaft pulley  $\rightarrow$  (D) Idler pulley A (flanged)  $\rightarrow$  (E) Tensioner pulley  $\rightarrow$  (F) Right-bank camshaft pulley

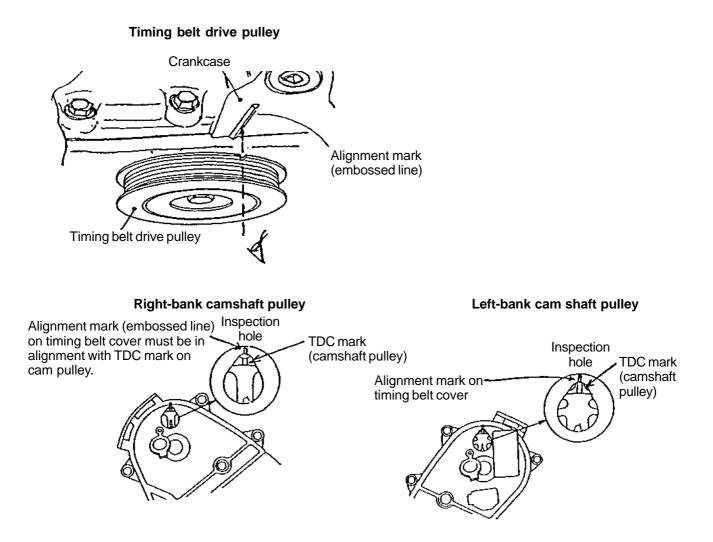
(6) Check that the TDC marks on the timing belt drive pulley and cam shaft pulley are in alignment with the top-dead-center point of compression stroke of No. 1 piston.

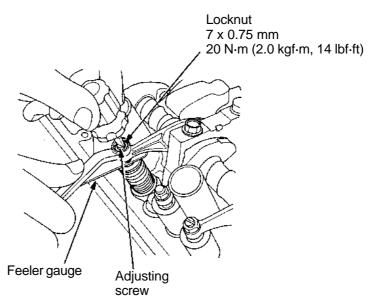
(8) Loosen lock nut on each rocker arm adjust screw. Turning the adjust screw, adjust tappet clearance.

[Standard tappet clearance] Intake: 0.20 – 0.24 mm Exhaust: 0.28 – 0.34 mm

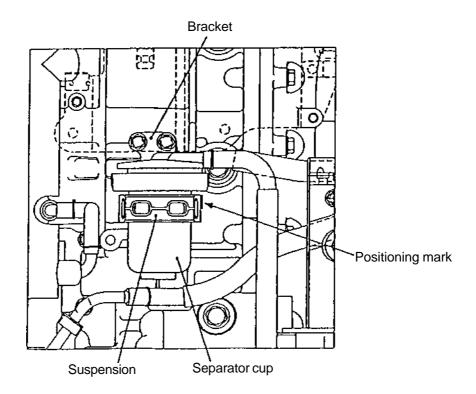
- Screw tightening torque: 3.4+/-0.7 Nm
- Align the fuel joint (outlet side) of the strainer to the positioning mark of the suspension.
- Check for fuel leakage after reassembly.

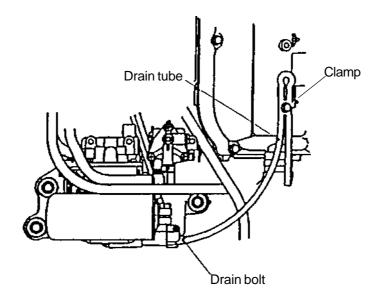
- (1) Disconnect the drain tube clamped at the bottom of the left-bank cylinder head cover, and put the tube end out to the front of the side cover.
- (2) Loosen the drain bolt of the vapor separator.

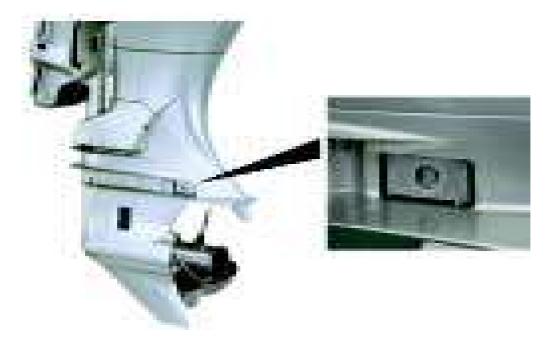
Anode metals on gear case

The anode metal has high potential difference from the surrounding metal, which enables it to make corrosion occur in itself, thus retarding propagation of corrosion to the surrounding metal. The BF200/225 uses a total of 6 pieces of anode metal: one each on the right and left sides of the gear case assembly and two each in right and left water jackets.

- Replace the anode metal if it is found badly corroded as a result of inspection.
- Inspect the anode metal whenever the water jacket cover is removed for servicing. It should be inspected at least once every 5 years.
